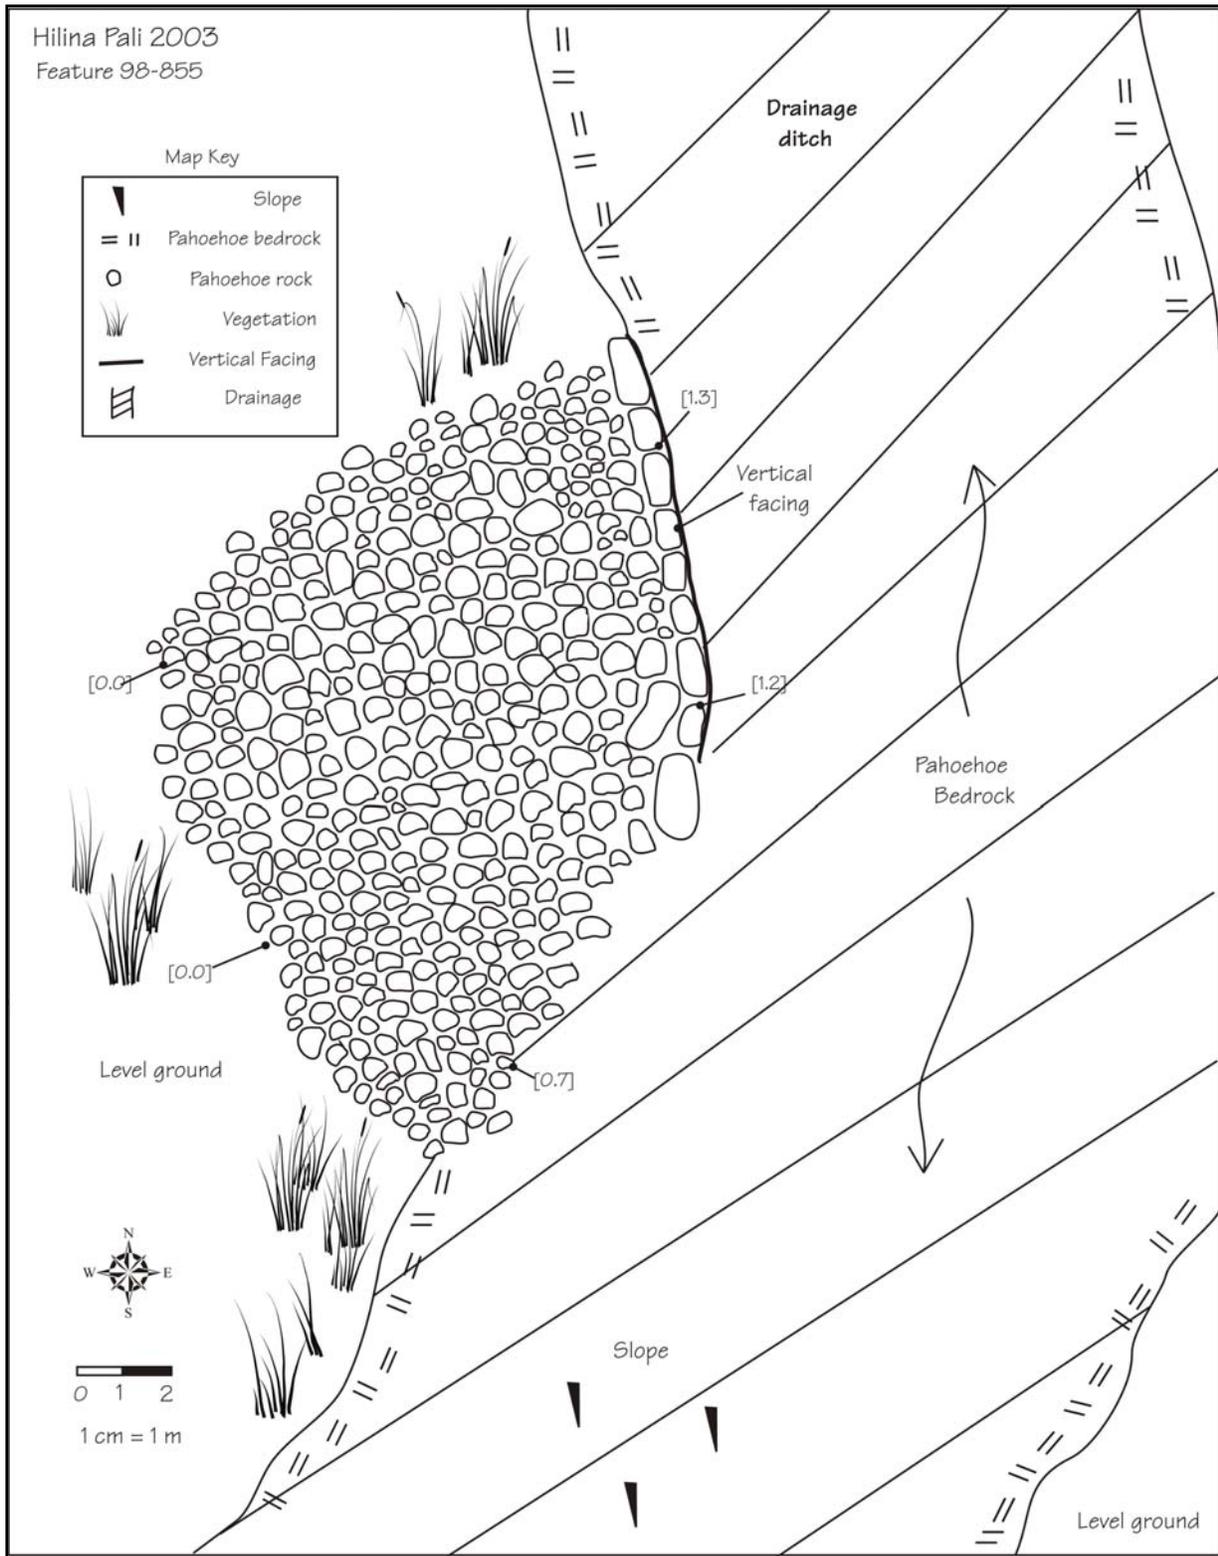
Figure 42. Feature HAVO-2005-D-43, Rock Wall

**HAVO-2005-D-43** (Feature 98-855) is a 6.7 m X 3.1 m X 1.1 m high wall constructed of large pāhoehoe boulders and some cobbles. The feature is a wall located on the NW side of the drainage. It is constructed with nicely faced upright and stacked pāhoehoe boulders 2-4 courses high. There are several cobbles deposited within the drainage to both N and S of the wall as well as a few large boulders to the south. The vegetation of the area includes *a'ali'i*, *pūkiawe*, molasses grass, and other grasses. The impacts include flooding and vegetation and the feature is in excellent condition.

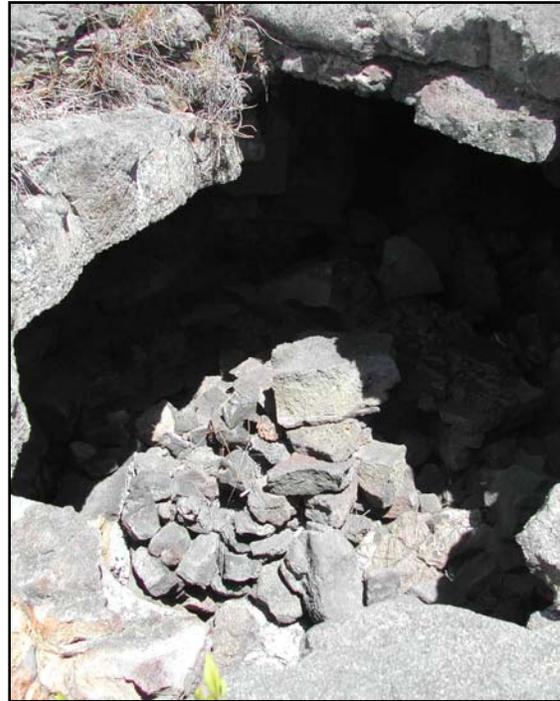
Other than the stacked rocks at the entrance the cave does not appear to have any cultural material inside. There is a large amount of soil deposited into the cave as well as mud and debris. The vegetation of the area consists of *pūkiawe* and the feature is in good condition.

**Figure 45. HAVO-2005-D-53,  
Stacked Rocks at Cave Entrance**  
Photo Courtesy of the National Park Service

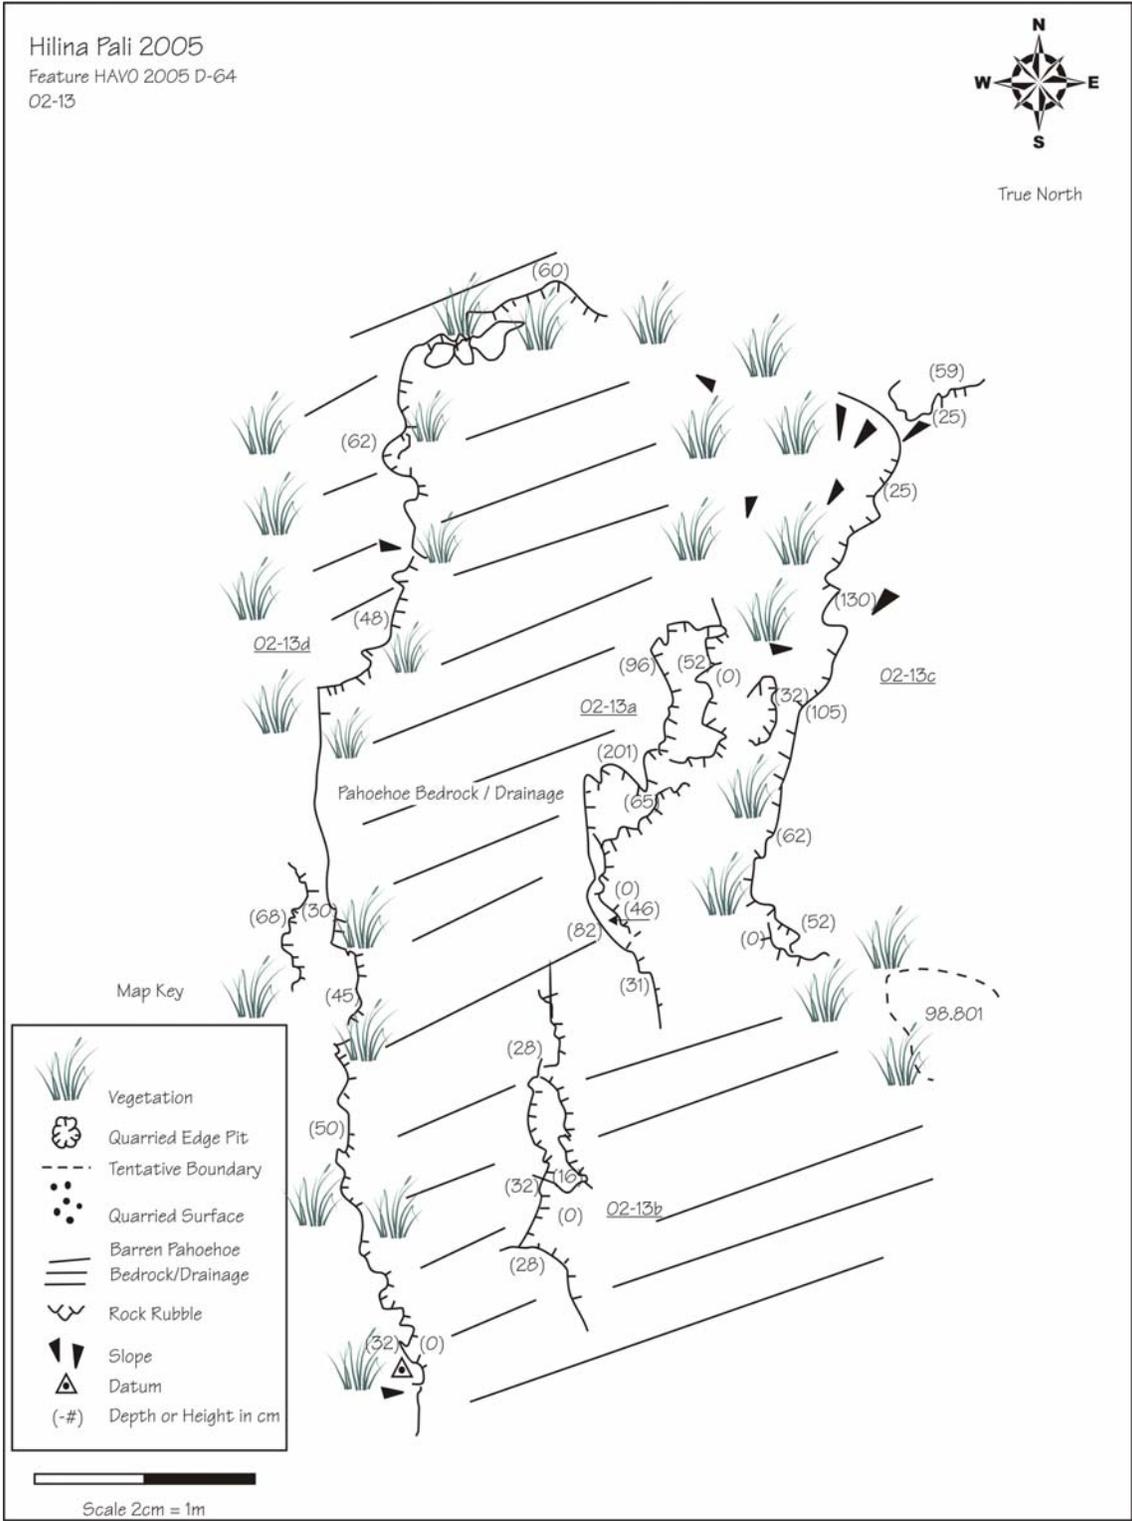
Figure 49. Feature HAVO-2005-D-64, Quarry

**HAVO-2005-D-64** (Feature 02-13 a, b) is a 8 m x 1.02 cm deep quarried edge. The edge faces E-SE with 1 shelf (6.7 m x 1.2 cm x 37 cm deep quarried shelf). 02-13b is a 8.4 m x 3.2 m deep quarried edge with a shelf 2.1 m x 70 cm x 16 cm deep. This quarry is SW of 02-13a. 02-13c is a 10.5 m x 1.3 m deep quarried edge. Located along the east bank of the drainage. 02-13d is a 21 m quarried edge. Sub-feature is located on the west bank of the drainage . The south section measures 8 m x 68 cm deep and the north section is 10.5 m x 62 cm deep. The impacts to this feature include floodwater, weathering, and vegetation. The vegetation consists of molasses grass, *a'ali'i*, *pūkiawe*, partridge pea, other grasses, and bracken fern. This feature is in good condition.

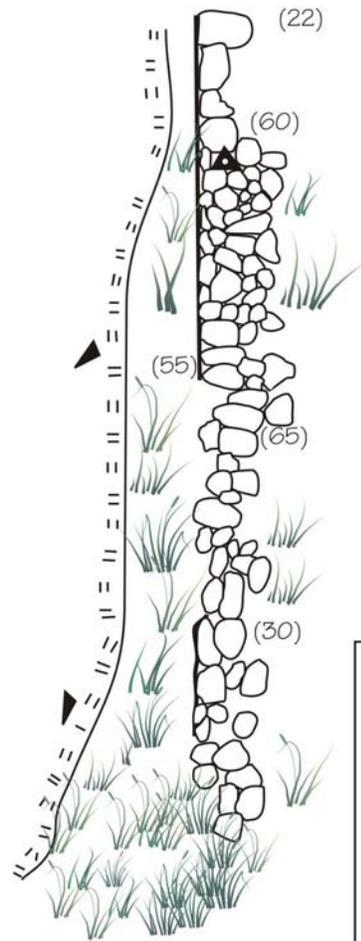
Hilina Pali 2002  
 HAVO-2005-D-34  
 Feature 98-839, wall  
 April 2005  
 Cartography By J. Burrell

**HAVO-2005-D-34** (Feature 98-839) is 6.75 m X 75 cm X 85 cm high wall constructed of porous basalt slabs and located on the natural contour on the east side of the drainage. The northwest end abuts a pāhoehoe outcrop. Slabs are placed upright to maximize the height. The rocks are stacked to a height of 2-4 rocks high. The medial to the south end is at a minimum stacking in a matrix of ashy soil and moderate to dense vegetation. The feature probably continues south but the vegetation is too dense to see. The vegetation includes *a'ali'i*, bracken fern, grasses, partridge pea, and *pūkiawe*. Impacts on the feature include weathering, seismic, and vegetation.

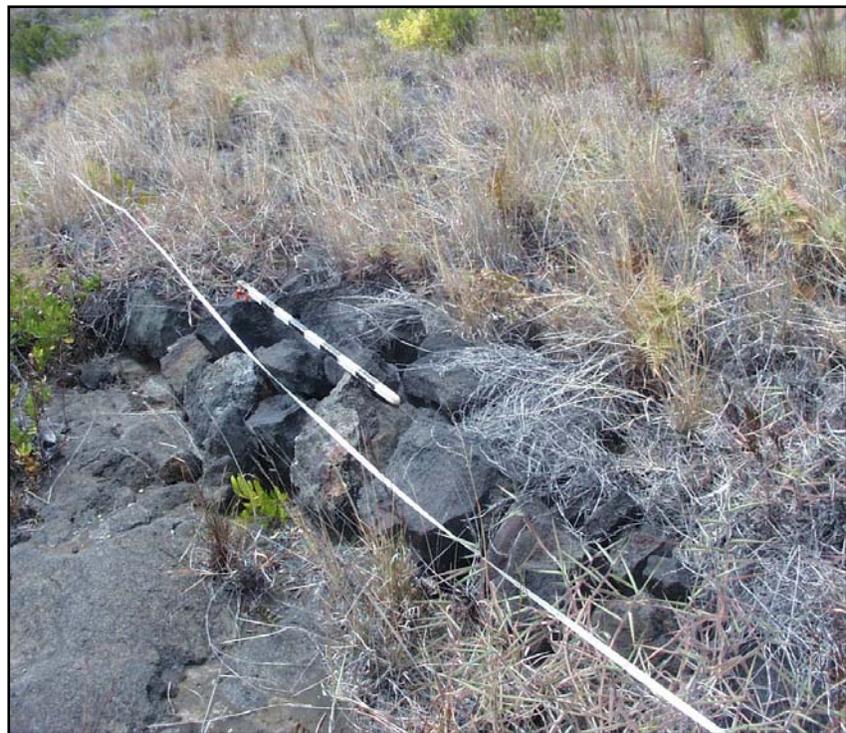
**Figure 56. HAVO-2005-D-95, Rock Wall.**

**HAVO-2005-D-95** (Feature 02-44) is a 12 m x 70 cm x 42 cm high wall. It is constructed of blocky pāhoehoe rocks stacked to a height of 1 to 2 rocks high. It is located southeast of 02-41. The rocks are cobble and boulder sized. The middle section of the wall is the best preserved. Types of impact include vegetation, seismic, weathering, and water. Vegetation consists of

*pūkiawe*, *a'ali'i*, partridge pea, fern, and grasses. This feature is in fair to poor condition.

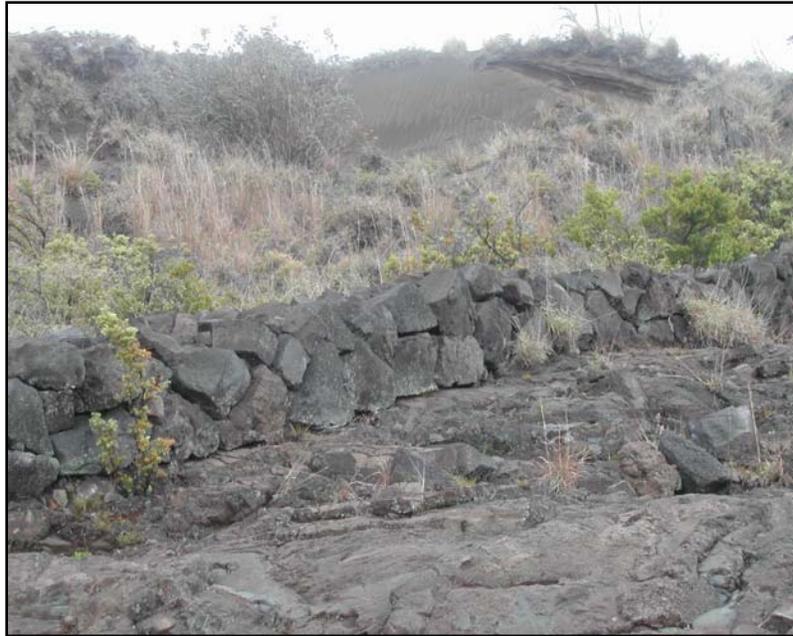
**Figure 59. Feature HAVO-2005-D-107, rock wall**

**HAVO-2005-D-107** (Feature 03-06) is an 8.5m X 50-110 cm wide X 40-60 cm in height rock wall. This is a very long rock wall built on the western edge of a pāhoehoe outcrop. The wall trends northwest-southeast. The southern portion of the wall is built with very blocky pāhoehoe boulders that are dry stacked very neatly so that they fit together nicely. The construction is very impressive. This portion of the wall is very linear approximately 30m long. After 30 m the wall is constructed with pāhoehoe boulders and also a lot of pahoehoe cobbles. The wall is not as intact and looks slightly collapsed and is invaded by vegetation. This wall is dry stacked 3-4 courses high. The function of the wall is as a retainer for water. To the west of the wall there are sand dunes. To the east of the wall is a pāhoehoe outcrop where the water is encouraged to flow into the drainage over the pahoehoe lava flow. Seismic activity, erosion and vegetation are potentially impacting this feature.

Vegetation surrounding this feature includes *pūkiawe*, *‘ōhi‘a*, ferns, grasses and *a‘ali‘i*. This feature is in excellent condition

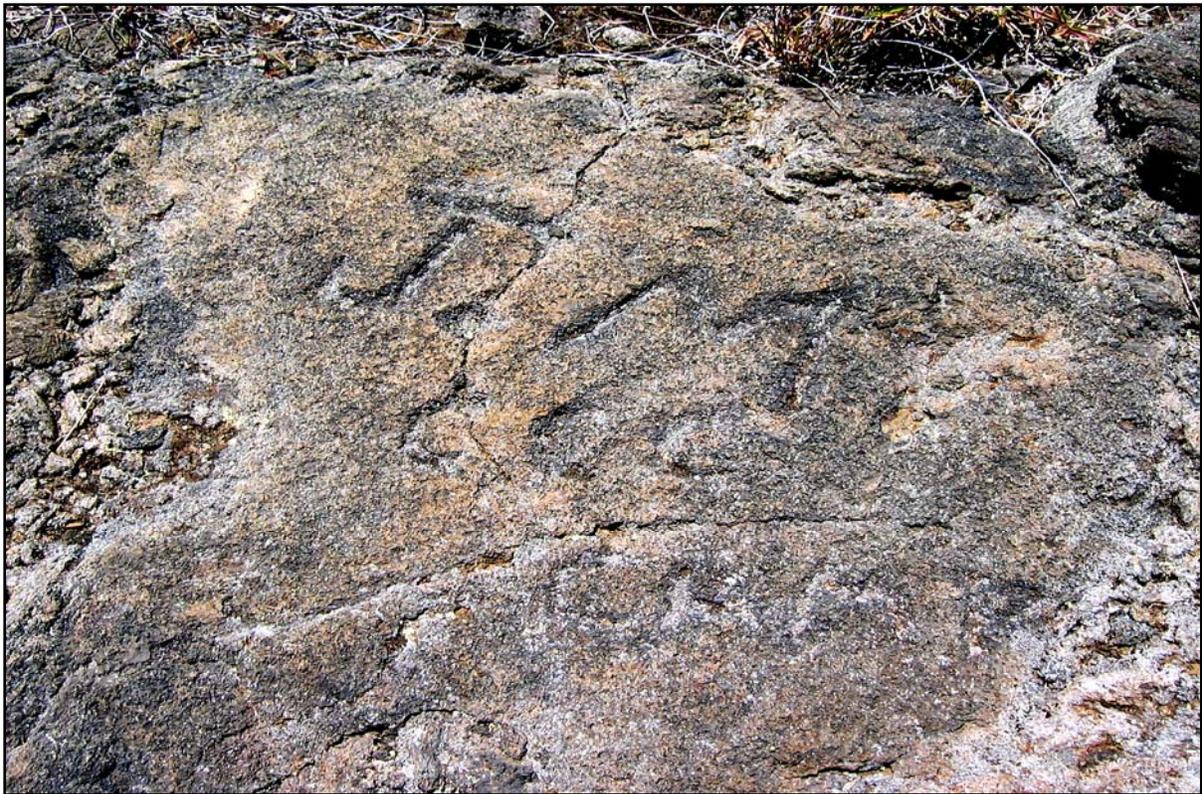
**Figure 61. Site Number 50-10-62-24523, HAVO-2005-D-110, Petroglyph**  
Photo Courtesy of the National Park Service

**HAVO-2005-D-110** (Feature 03-12) is a 45 cm X 30 cm pecked petroglyph. The petroglyph is pecked from pāhoehoe bedrock and is comprised of the letters "J. M." and underneath these letters are the letters "C.C.C. Camp". Also within a 5 meter vicinity of this petroglyph are three others. One reads the initials "E C H," one is not legible and the other one reads H M L with the letters connected. The petroglyph is large and visible and located near a rock shelter overhang opening (03-14) as well as another C.C.C petroglyph recorded in (03-17). The area the feature is located in is vegetated by *pūkiawe*, *‘ōhi‘a*, *a‘ali‘i* and grasses. It is in excellent condition (see figure 61).

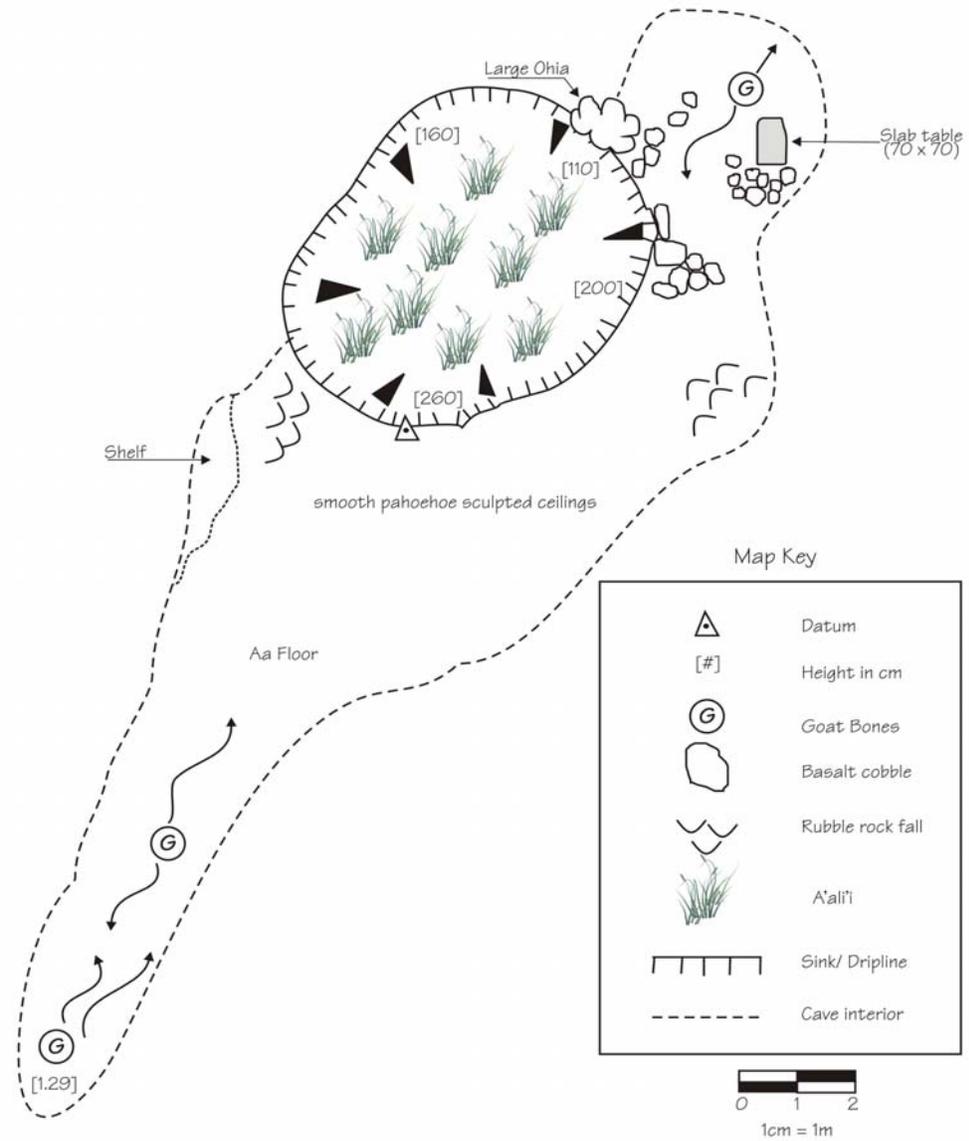
Figure 62. Site Number 50-10-62-24524, Feature HAVO-2005-D-116, Rock Shelter

**HAVO-2005-D-116** (Feature 03-14) is a overhang/rock shelter formed in the natural pāhoehoe flow. The dimensions of the entrance sink are 7 m X 5 m X 1-3 m deep. The opening of the tube is very circular and is being invaded by vegetation. On the east side of the tube opening is a

small room with the dimensions 6 m X 2.8 m X 1.25 m high. In this room there is a deliberately made table constructed from a large pāhoehoe slab (approximately 1m X 1.5 m) that rests on top of five stacked pāhoehoe blocks. The table is approximately 0.5 m high from the tube floor. The tubular portion of the cave extends towards the south and is full of goat bones. It goes back approximately 15 meters and possibly continues but the continuation is not accessible from this portion of the tube. The southern portion of the rock shelter has very impressive geological formations at the entrance on the smooth pahoehoe walls. The formations are smooth and includes a pillar and a complex web of lava flow formations. This section of the rock shelter extends back approximately 14 meters. This tube would serve as a good shelter and found near two CCC petroglyphs. The vegetation of the area includes *a'ali'i*, *'ōhi'a*, *pūkiawe*, and grasses. The impacts of the feature include goats, vegetation, and human impacts and the feature is in good condition.

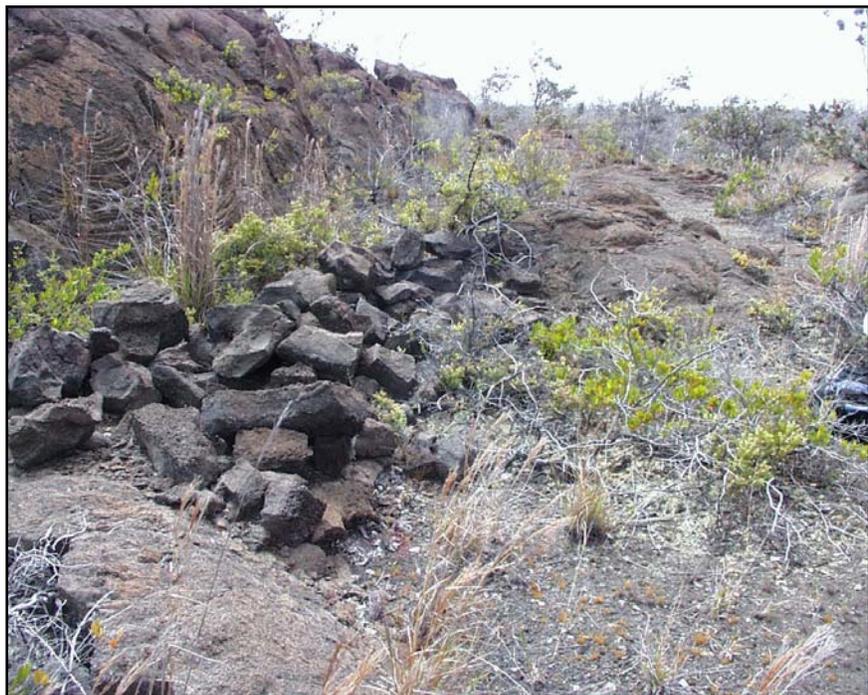
**Figure 64. HAVO-2005-D-122. Rock Wall**  
Photo courtesy of the National Park Service

(Feature 98-35) is a 3.3 m X 1.05 cm X 0.50 m in height rock wall constructed with pāhoehoe cobbles and boulders very loosely stacked 1-2 courses high. The wall is located southeast of a pāhoehoe tumulus and may have served as a temporary shelter. To the northwest of the feature it appears that there is some possible excavation. Seismic activity and vegetation are potentially impacting this feature. Vegetation surrounding this feature includes *pūkiawe*, *ōhi'a*, grasses and *a'ali'i*. This feature is in fair condition.

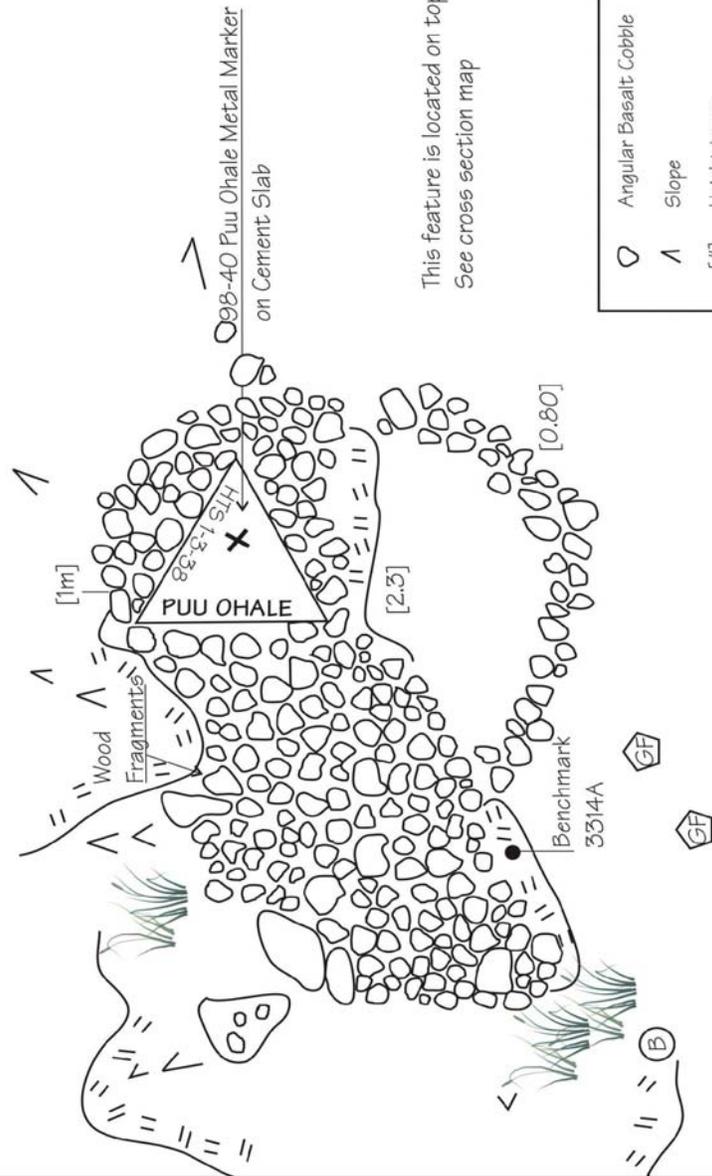
Figure 69. HAVO-2005-D-125 and HAVO-2005-D-128

**HAVO-2005-D-128** (Feature 98-305) is a 4.5 m x 1.4 m and 1 m in height enclosure. The enclosure abuts a pāhoehoe tumulus that is north of the feature. On top of the tumulus is a pu‘u ohale, see feature 98-40. The enclosure curves in shape and is made of huge pāhoehoe cobbles and boulders stacked up to 5 courses high. Inside the enclosure there are many loose pāhoehoe

rocks. Around the feature there are many broken bottles and some old aluminum cans. Potential impacts to this feature include seismic activity, vegetation and human. Vegetation surrounding this feature includes *pūkiawe*, 'ōhi'a and a'ali'i. This feature is in good condition.

This feature is located on top of a very high tumulus  
 See cross section map

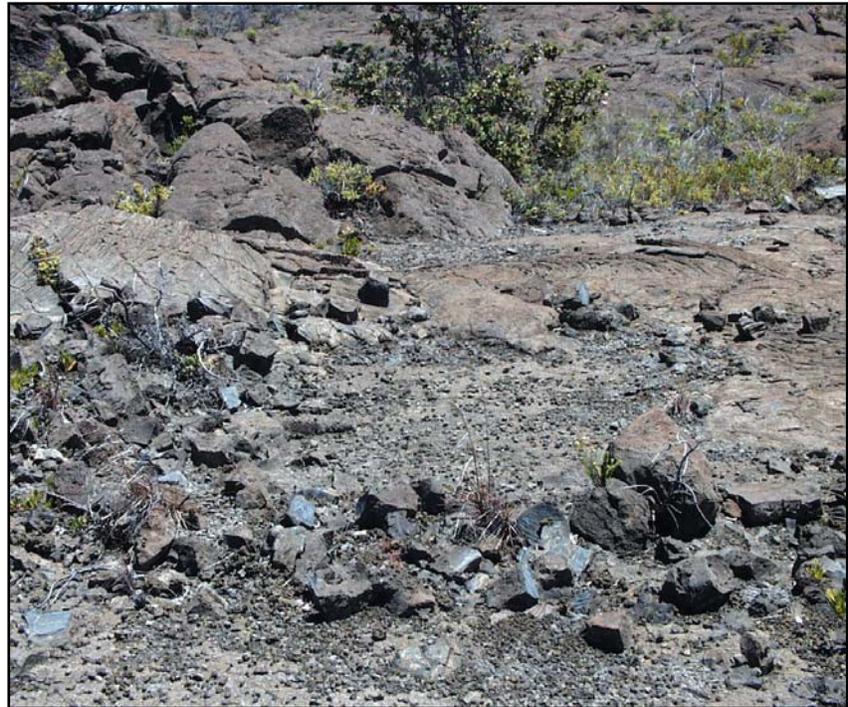
**HAVO-2005-D-131** (Feature 98-308) is a 2.4 m x 2.4 m and 27 cm in height c-shape constructed with small blocky pāhoehoe cobbles, some of which are chilled glass. The open part of the c-shape faces northeast. The pāhoehoe rocks are stacked 1-2 courses high and looks as if it is collapsed. Located approximately 10 m to the south is a larger enclosure recorded as feature 98-37. Potential impacts to this feature include seismic activity and vegetation. Vegetation surrounding this feature includes *pūkiawe*, 'ōhi'a, grasses and a'ali'i. This feature is in fair condition.

**Figure 71. HAVO-2005-D-131. C shape temporary shelter, Ka'u Desert**

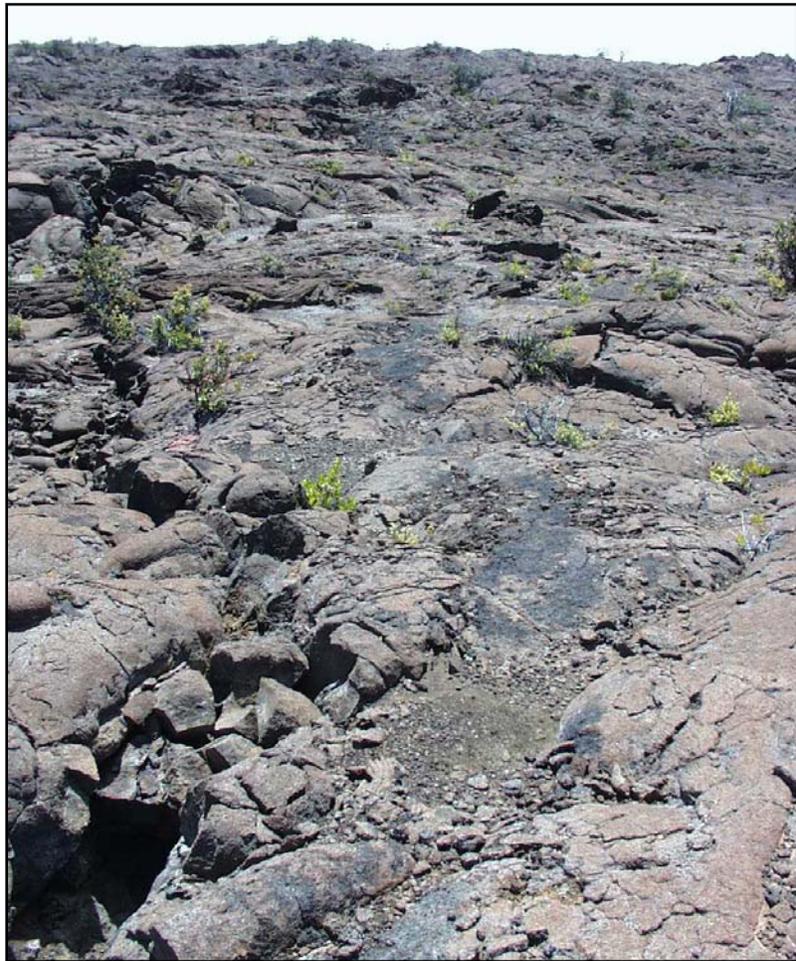
**Figure 74. HAVO-2005-D-150, worn trail.**  
Photo Courtesy of the National Park Service

**\*HAVO-2005-D-150** (Features 03-10A and 03-10B) are the start and end point of a relatively short worn trail that parallels and eventually meets up with the trail and *ahu* at feature 03-09 (at the top of the fault scarp) and also meets to the west at feature 98-390. This trail trends north-northwest along smooth but worn pāhoehoe lava. The pāhoehoe lava has a reddish color to it, while the trail is dark gray in color making it easy to follow. Seismic activity impacts this feature.

Vegetation surrounding this feature includes *'ōhi'a*, *pūkiawe* and *a'ali'i*. This feature is in good condition.

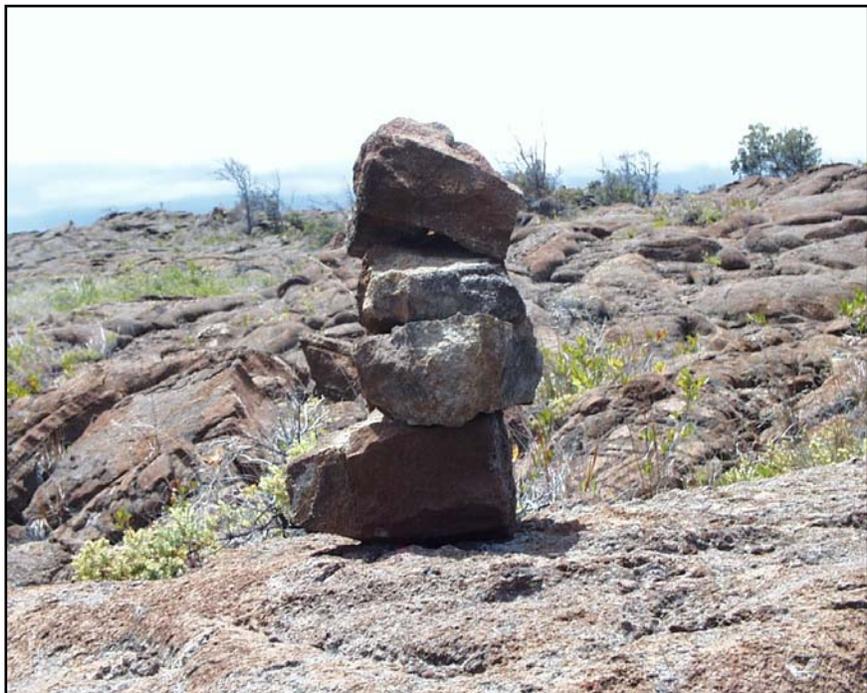
(Feature 03-11) is a 0.45 m long X 0.20 m wide X 0.65 m in height *ahu* located approximately 40 meters away from the trail and *ahu* at feature 98-387. The *ahu* is constructed with small to large pāhoehoe cobbles stacked 4 courses high. This feature could potentially be impacted by seismic activity.

Vegetation surrounding this feature includes *'ōhi'a*, *pūkiawe* and *a'ali'i*. This feature is in excellent condition

**Figure 75. HAVO-2005-D-151. Ahu trail marker**
